JUBA-RUMBEEK-MAYENDIT-BENTIU-WAU-MUNDRI ROAD ASSESSMENT MISSION

Date(s):	06 – 18 July, 2013
Location(s):	Juba-Yirol-Rumbek Rumbek-Maper-Mayendit-Bentiu Bentiu-Mayom-Abiemnhom-Kuajok-Wau Wau-Tonj-Rumbek Rumbek-Mvolo-Munrdi-Jambo-Juba
Participating Organisation(s):	Logistics Cluster, UNOPS
Security:	Levels 1, 2, & 3

LOGISTICS CLUSTER – SOUTH SUDAN

ROAD ASSESSMENT

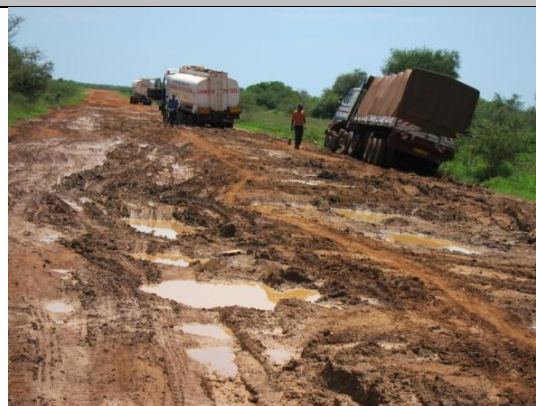
- Juba to Terakeka Road is Tarmac (all weather) for the first eight kilometres. The remaining road section is gravel and is slightly damaged with many potholes. However, the road is passable with difficulty for all traffic during the rainy season. The road section will further deteriorate due to heavy trucks transporting gravel from barrow pits to Juba (See photo A).
- Terakeka to Yirol road is gravel and badly damaged at various sections. Only light vehicles can pass during the rainy season, and only after two dry days. There are some culverts which need to be installed and/or repaired to enable traffic to pass smoothly. A private contractor is rehabilitating the road section (spot repairs) from Awerial to Yirol (See photo B, C, D).

A. Juba-Terakeka Road

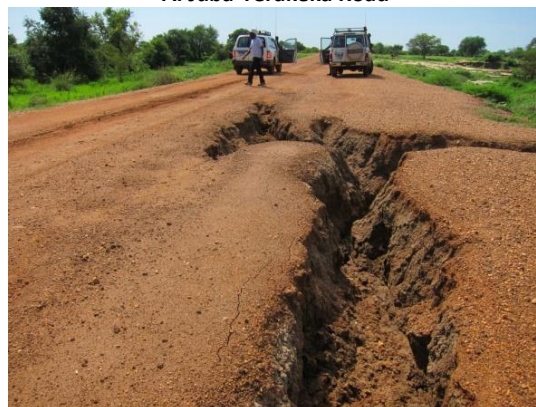
B. Road erosion at culvert after Terakeka Junction

- Two culverts and the road section between Terakeka and Awerial need to be rehabilitated immediately to enable humanitarian access during the rainy season.

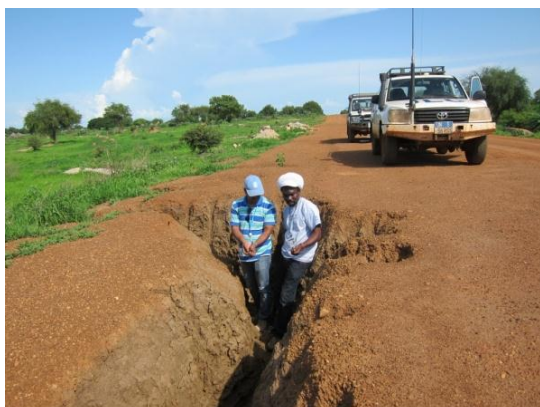
C. Road erosion at Gongor culvert

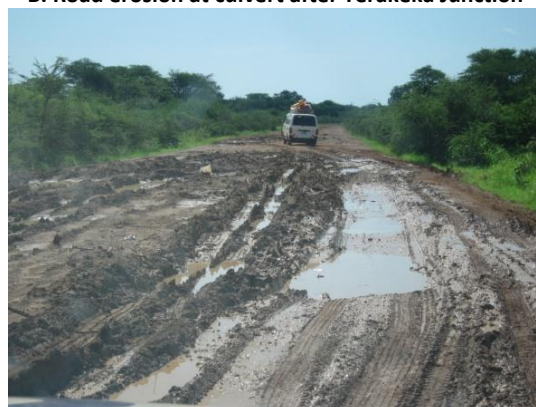
D. Terakeka-Awerial road is in bad condition

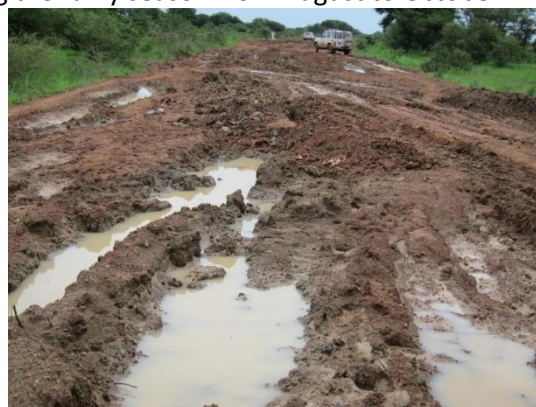
- Rumbek to Maper Road is gravel and smooth for first 30 km and then the road is rough (with many potholes) for the following 70km and is only passable with difficulty for light vehicles after two dry days during the rainy season (see photo E).
- Maper to Mayendit Road is gravel up to the Madol (approximately 30km) and the following 32km is sandy and black cotton soil. This section (Maper-Mayendit road) is severely damaged and impassable for all traffic during the rainy season. Many new culverts are required at the damaged road sections along Madhol-Mayendit. Maper-Mayendit Road section will further deteriorate with heavy rains and may not passable for any traffic from August-October (see photo F, G, H, I, J).

E. Road damaged before Maper (40km, after 3 dry days)

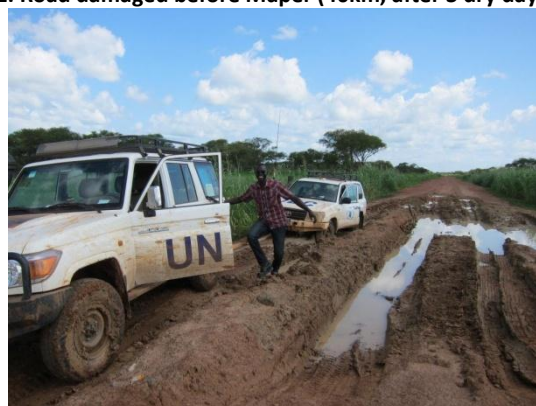
F. Road damaged after Maper (20km, after 3 dry days)

- Rumbek-Bentiu Road corridor needs to be rehabilitated at the key damaged road sections (Maper-Mayendit; Mayendit-Mir Mir-Tharjath) and the Mayendit Culvert needs to be repaired immediately.

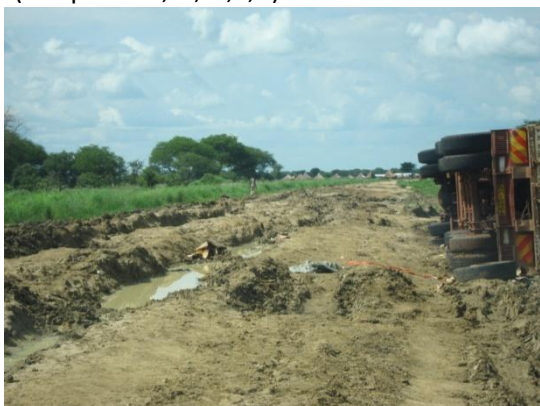
G. Road damaged before Madol (after 3 dry days)

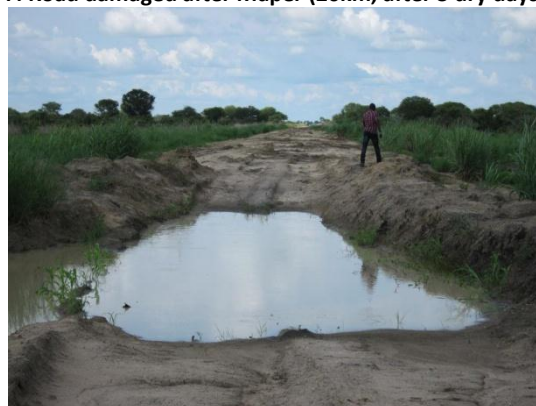
H. Road damaged after Madol (after 3 dry days)

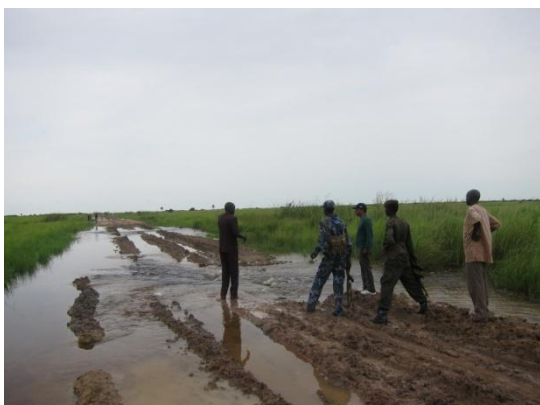
I. Flooding before Mayendit (2 September 2012)

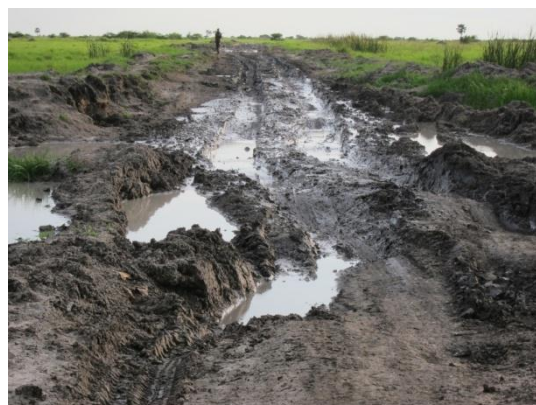
J. Road damaged before Mayendit (8 July 2013)

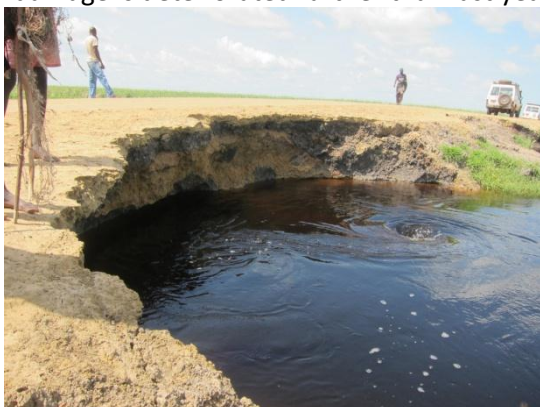
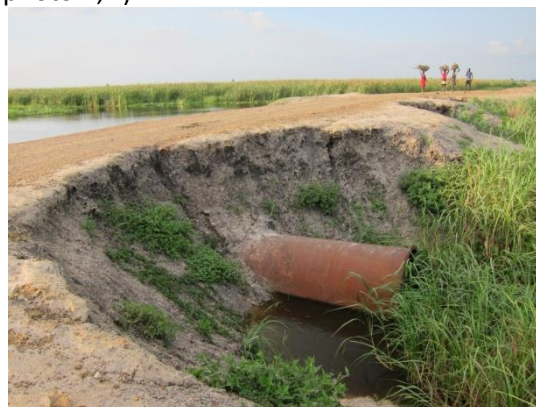
- Mayendit Culvert was damaged last year and has not yet been repaired. The soil has eroded for more than a year which may cause the restriction of traffic even during the dry season due to its location in proximity to the Mayendit River). Mayendit Junction to Mayendit Road was flooded during a previous Logistics Cluster mission during the first week of September 2012 and the damage is deteriorated further than last year (see photo K, L).

K. Mayendit culvert road eroded (2 Sep 2012)

L. Mayendit culvert road eroded (8 July 2013)

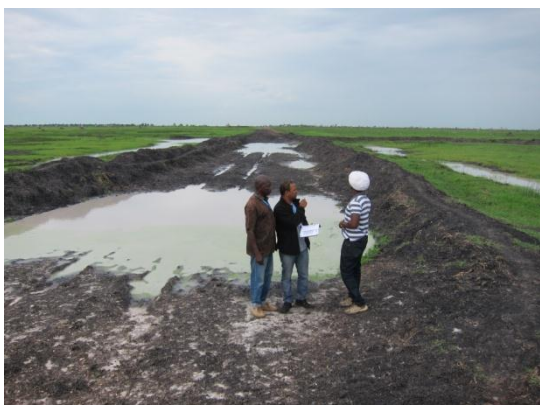
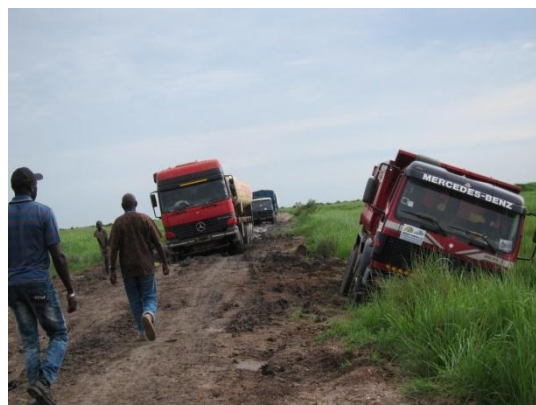
- During this mission private trucks were still attempting to use the Rumbek-Bentiu Road corridor. Once the transporters discovered that the road section has deteriorated they returned back to Rumbek and diverted to the Wau Road corridor to reach Bentiu. Trucks are still attempting to use the Bentiu-Rumbek Road corridor from Bentiu due to check points and insecurity along the Bentiu-Mayom Road.
- A two foot high dike wall has been constructed with local black cotton soil around Mayendit town to protect it from flood water during the rainy season.
- Mayendit to Leer Junction Road and culverts are severely damaged which makes this section impassable for all traffic from August - October (see photo M, N).

M. Mayendit-Leer Junction road (after 3 dry days)

N. Mayendit-Leer Junction road (after 3 dry days)

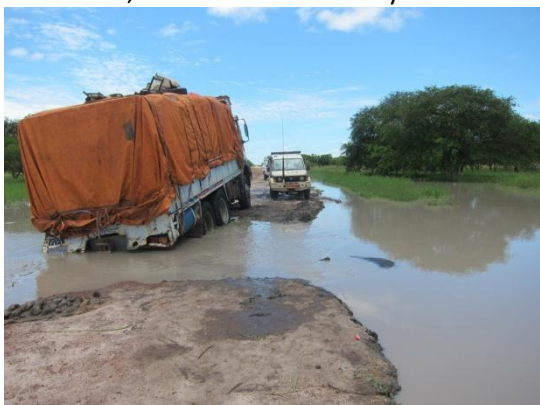
- Leer Junction to Mir Mir Road section is currently passable for light vehicles only. The local community is carrying out temporary repairs to the potholes and some culverts with local wood and road side sand at washed away road sections. These spot repairs by the local community on trunk roads will not sustain for long periods due to the heavy traffic and impending rains. The road will become inaccessible for all traffic due to flooding and heavy use in the current condition, even with community hand rehabilitation (see photo O, P).

O. Rupkuai culvert road eroded (2 Sep 2012)

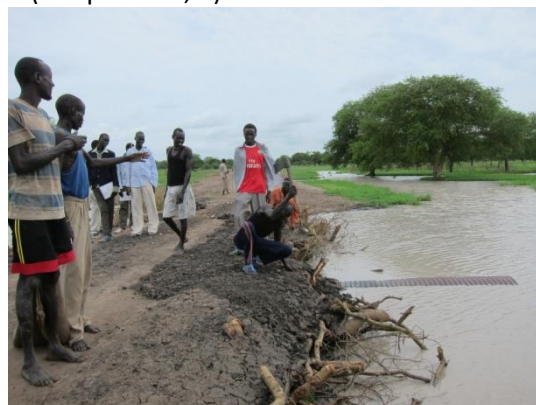
P. Rupkuai culvert repaired by local community (11 July 2013)

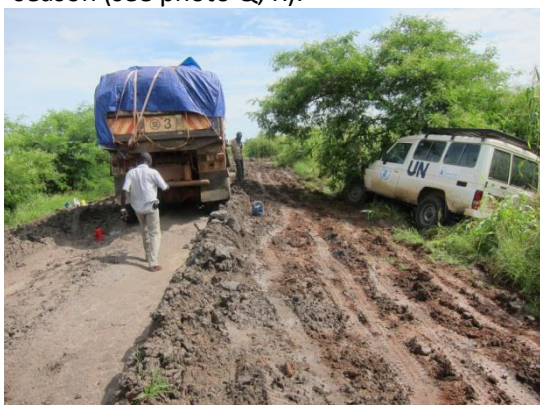
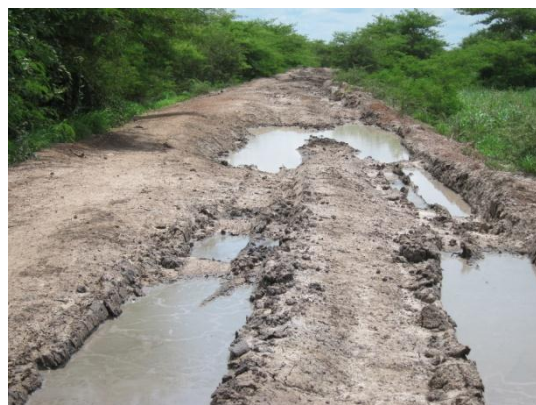
- Mir Mir to Tharjath Road is severely damaged and impassable for all traffic during the rainy season (see photo Q, R).

Q. Mir Mir-Tharjath road damaged (2 Sep 2012)

R. Mir Mir-Tharjath road damaged (11 July 2013)

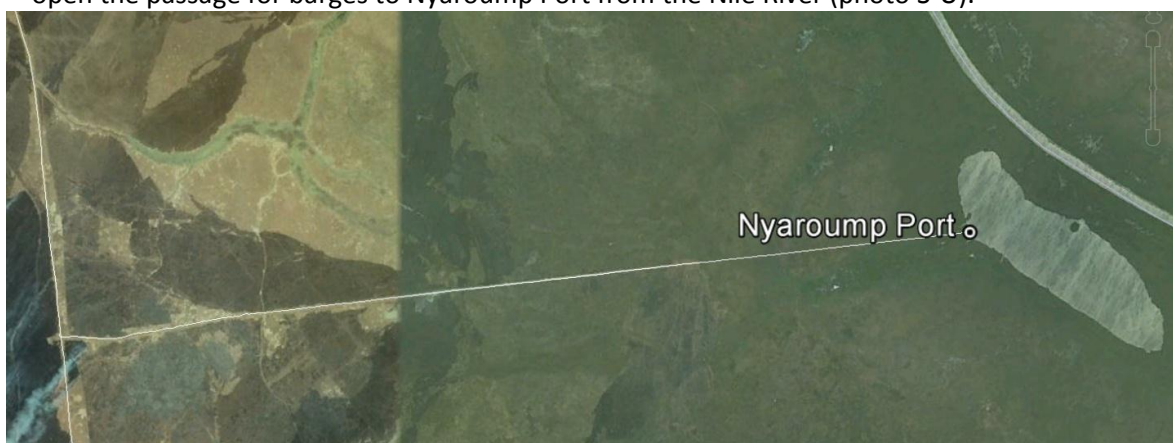
approximately 100km from Bentiu, near the Tharjath (20km) (see map). The approach by road is gravel and usable during all seasons to the port. The port is often used by private companies to bring drinking water from the Nile River to Tharjath. The port access road is 10 km from the main road and is in good condition and passable for trucks (limited to 40mt) during all seasons. The port is located on the bank of Nyaroump Lake which is connected to the Nile River. There is substantial elephant grass which divides the lake and river and which makes movement of barges not possible. The port has a landing site (100 m wide and 80 m long) which is compacted with gravel and suitable for traffic during all seasons. There is a docking wall present to allow for large barges to operate at the port, however, as mentioned it is currently not possible with the existing elephant grass. According to the local authority, grass clearance can be conducted in two days to open the passage for barges to Nyaroump Port from the Nile River (photo S-U).

S. Nyaroump Port road and Port Lake on Google Map (2010); Between Lake and Nile River the distance is approx. 400m

- Ten trucks were stuck along the Bentiu-Rumbek Road corridor due to heavy rains and poor road conditions.
- Elephant grass needs to be cleared between Nyaroump Port Lake and Nile River to allow barges to dock which will be the only way to reach Bentiu during rainy season with the current infrastructure.

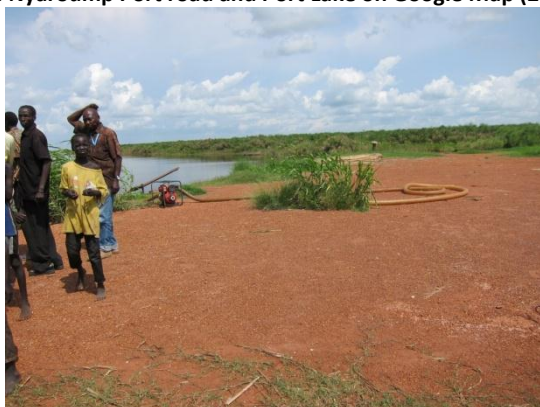
T. Nyaroump Port

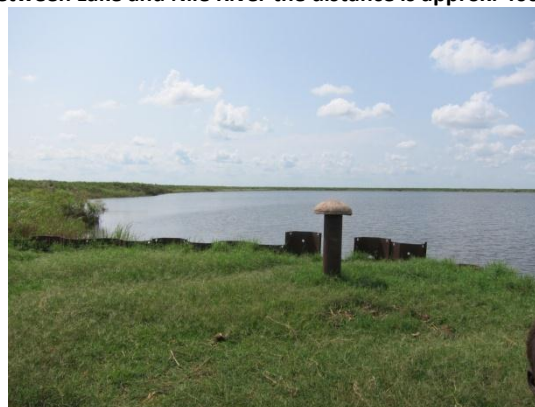
U. Nyaroump Port on Nile River

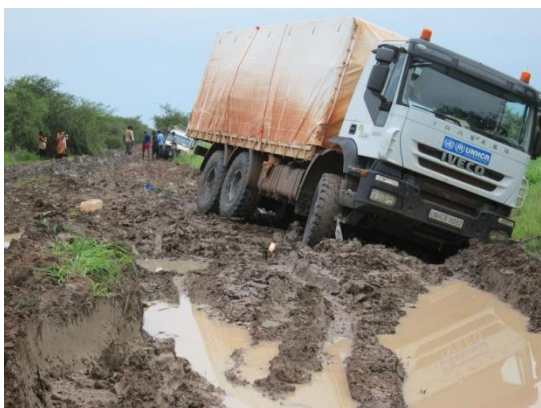
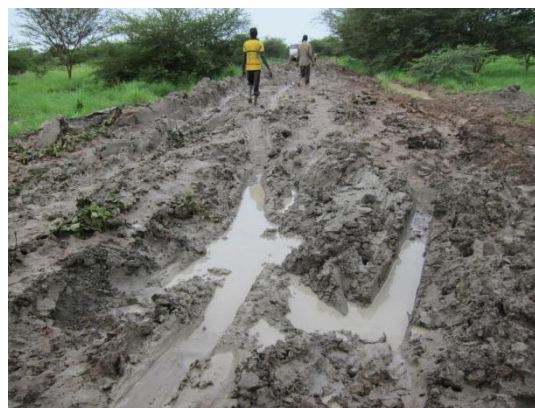
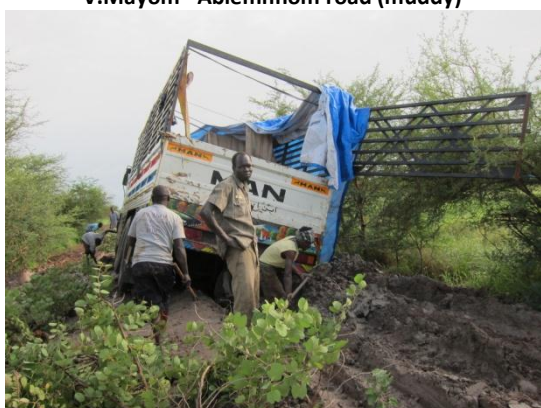
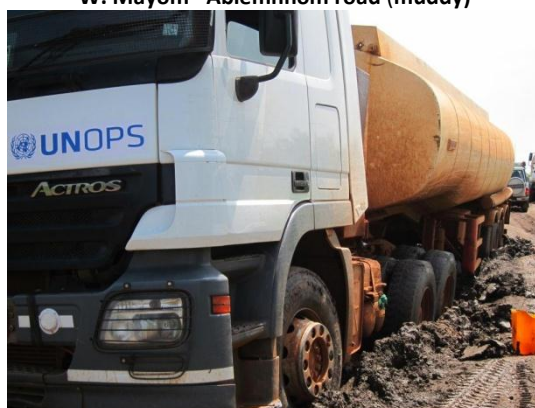
- Bentiu to Mayom Road is gravel from Bentiu to Tumor and is smooth and passable for all traffic during all seasons. Tumor to Mayom Road section is rough and passable with difficulty, only for light vehicles during the rainy season.
- Mayom to Abiemnhom Road is severely damaged and impassable for all traffic during the peak of the rainy season (August to October). During this mission, approximately 20 trucks were observed stuck along the road stretch, including light vehicles between Mayom and Abiemnhom (see photo V-Y).

V. Mayom –Abiemnhom road (muddy)

W. Mayom –Abiemnhom road (muddy)

X. Mayom-Abiemnhom road (muddy)

Y. Mayom-Abiemnhom road (muddy)

- Mayom to Abiemnhom Road needs to be rehabilitated immediately to allow humanitarian access to Bentiu and further to Refugee camps in Unity State.
- Luri River Bridge needs to be repaired immediately as the drift culvert and bridge are one of two main road corridors critical to gaining access to Western Equatoria and Lakes states.

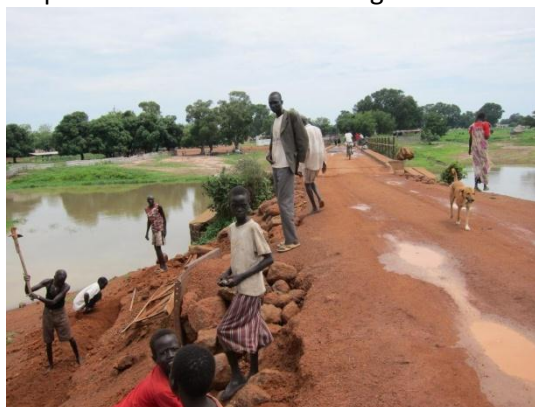
- Wau to Cuibet Road is gravel and smooth and is passable for all traffic during all seasons.
- Tonj Bridge was reconstructed in April 1974 by the government and is still in good condition. The Tonj Bridge access road potholes are under rehabilitation by the local authorities. The bridge is passable for all traffic during all seasons (see photo Z).
- Cuibet to Rumbek Road is gravel and rough (with many potholes) however the road is passable, with difficulty, for all traffic during all seasons (see photo AA).

Z. Ton Bridge access Road

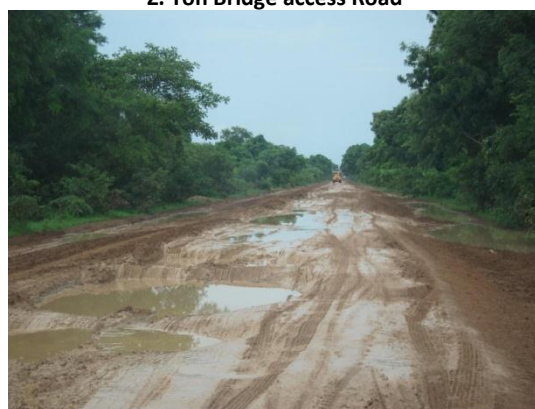
AA. Cuibet to Rumbek Road

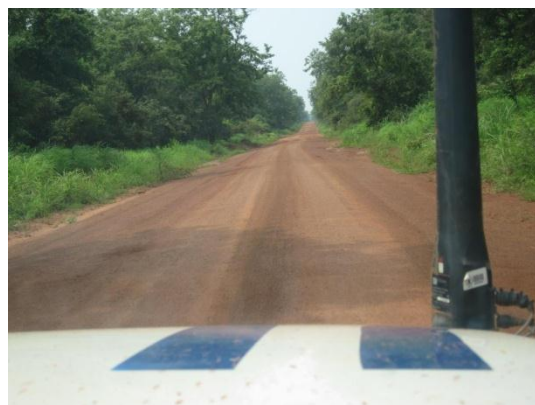
- Rumbek to Mvolo Road is gravel and smooth and passable for all traffic during all seasons. The road section is rough fifteen kilometres before Doteku and the following fifteen kilometres after Doteku. However, the road is passable for all traffic during all seasons (see photo AB).

AB. Rumbek to Wullu Road

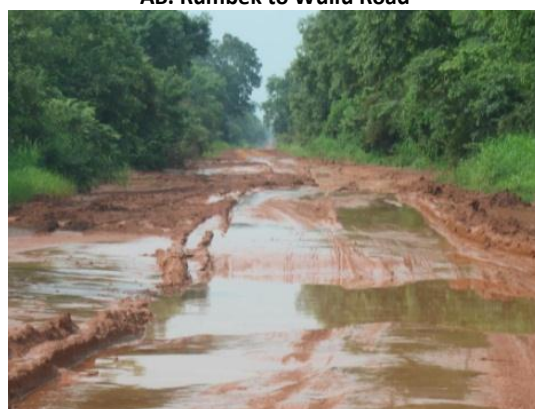
- Mvolo to Mundri Road is gravel and smooth up to Mayewe. After Mayewe, the road is moderately damaged with many potholes however all traffic is passable, with difficulty, during all seasons (see photo AC).

AC. Mayewe to Mundri junction Road

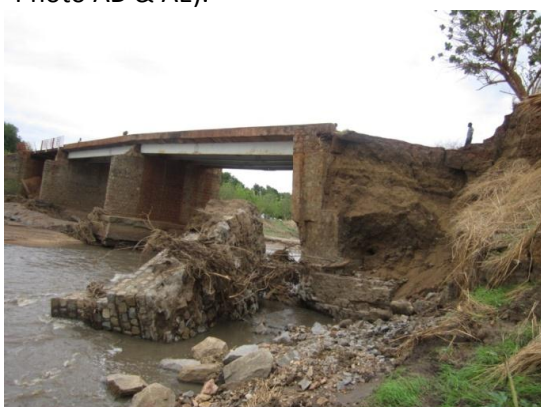
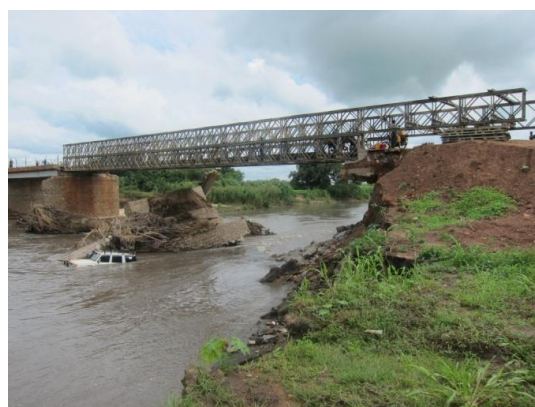
The Luri Bridge is located 20km outbound from Juba on the Juba-Rokon-Mundri Road. The bridge was damaged/tilted on 27 April 2012 which resulted in the full closure of the crossing for several weeks. A drift culvert was built by a private construction company on 09 May 2012. On 26 June 2012, a new Bialy Bridge was installed at the site of the old damaged/tilted bridge section. Currently, the newly installed Luri Bridge section (approximately 40m long and 6m wide) abutment wall has collapsed and is not currently passable for any traffic. During periods of heavy rain the drift passage will not be passable for any traffic on the Luri River (this includes pedestrians and motorcycles).

- Luri Bridge is impassable for all traffic. The newly built access road and abutment base to the bridge has collapsed and the bridge is impassable for all traffic including pedestrians/motorcycles. The span of the bridge is approximately 60m long and 7m wide (see Photo AD & AE).

AD: Luri Bridge, damaged on 27 April 2012(before)

AE: Luri Bialy Bridge installed on 26 June 2012 (after)

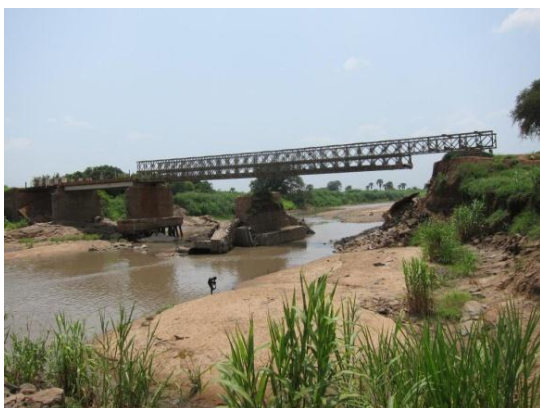
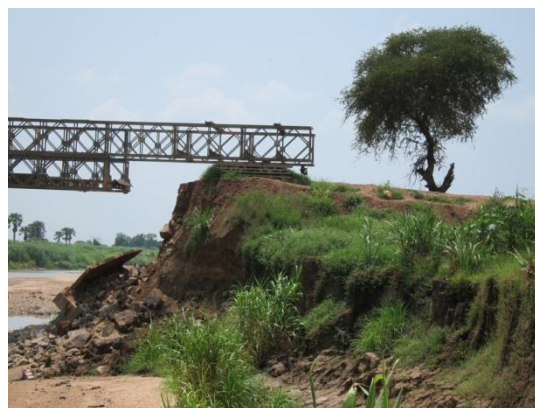
- However, the newly constructed Bialy Bridge is built on the old abutment and is only 40m long by 6m wide (approximately). The drift culvert section is passable only for heavy traffic after three days without rains and only if water levels are less than one meter on the drift. Passage for light vehicles and motorcycles is currently not recommended as it is dangerous to pass via the drift culvert and may result in vehicle loss (see photo AF-AI).

AF: Luri Bridge, damaged on 18 July 2013(after)

AG: Luri Bridge, damaged on 18 July 2013(after; close-up)

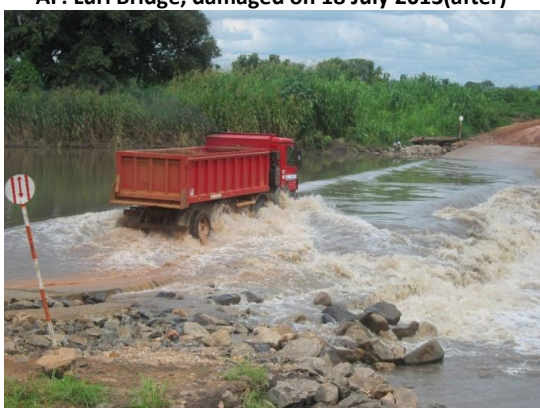
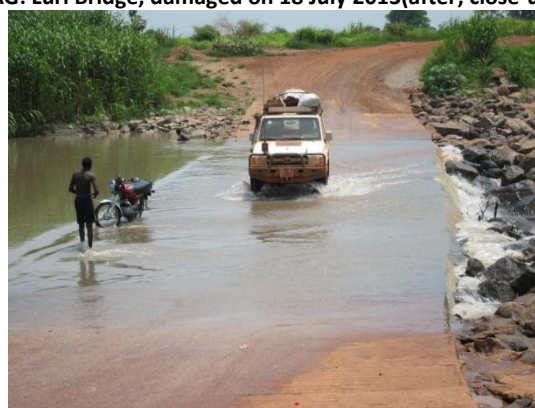
AH: Traffic passing Luri River on 22 August 2012

AI: Traffic passing Luri River on 18 July 2013
